AIRTIGHTNESS TESTS ON COMPONENTS USED TO JOIN DIFFERENT OR SIMILAR MATERIALS OF THE BUILDING ENVELOPE

Prepared for: Mr. Jacques Rousseau
Project Manager
Project Implementation Division
Canada Mortgage and Housing Corporation
682 Montreal Road
Ottawa, Ontario
K1A 0P7

Submitted by: Air-Ins Inc.
2217 Guenette Street
St-Laurent, Quebec
H4R 2E9

Date: September 27, 1991

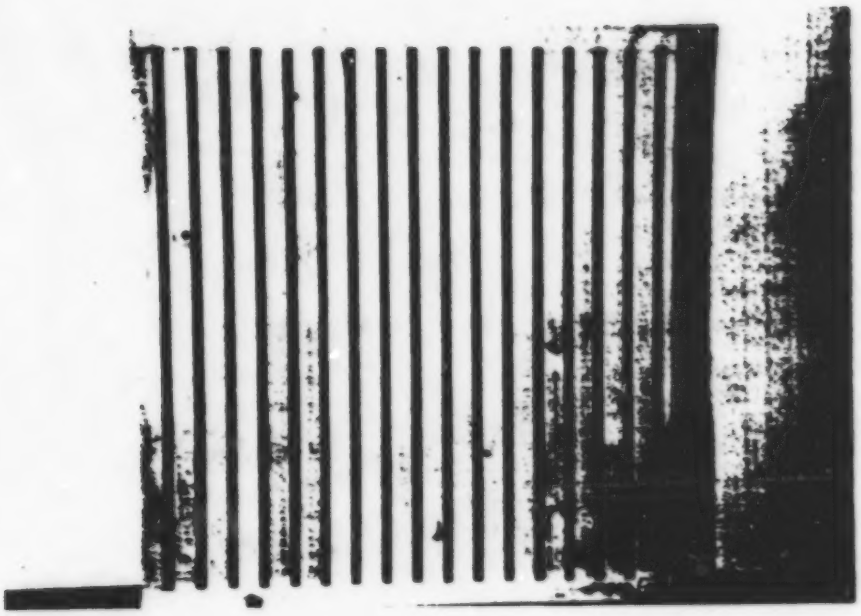
Photo No. 9

Specimen: No. 9- EPDM Gap Gasket (Photo no. 9).

This joint proved to be rather air tight, but once again the problem of air tightness at the ends of the joints is critical. The small difference in air tightness between the beginning and the end of the test is undoubtedly due to the handling to set up and take down the assembly which accentuated the losses at the ends of the joints.

SPECIMEN NO. 9: EPDM Gap Gasket

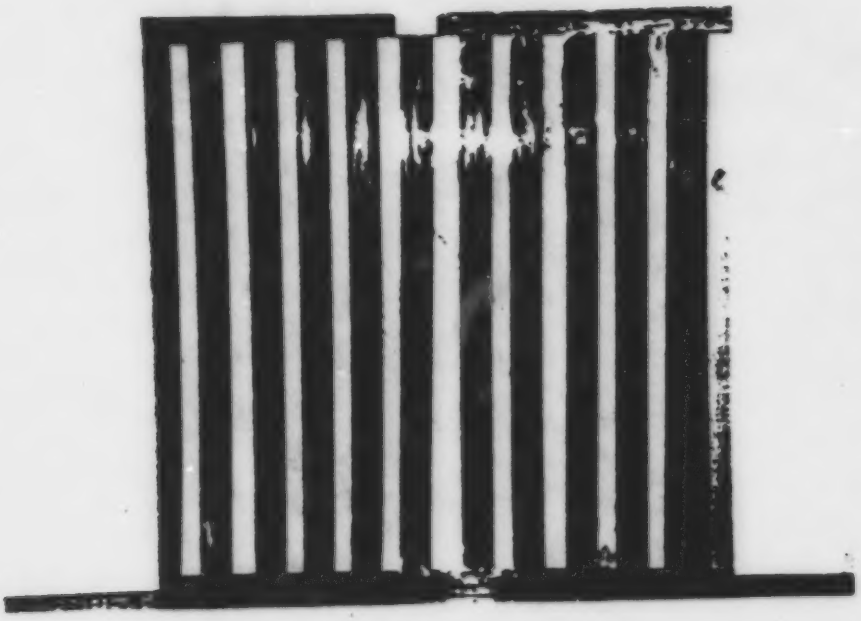
Photo No. 14

Specimen: No. 14- Adhesive tape on spun bonded ofelin paper joint.
(14-1, 20°C) Photo nos. 14 and 14A)
(14-2, -20°C)
(14-3, 65°C)

SPECIMEN NO. 14: Adhesive tape on spun bonded ofelin paper joint.

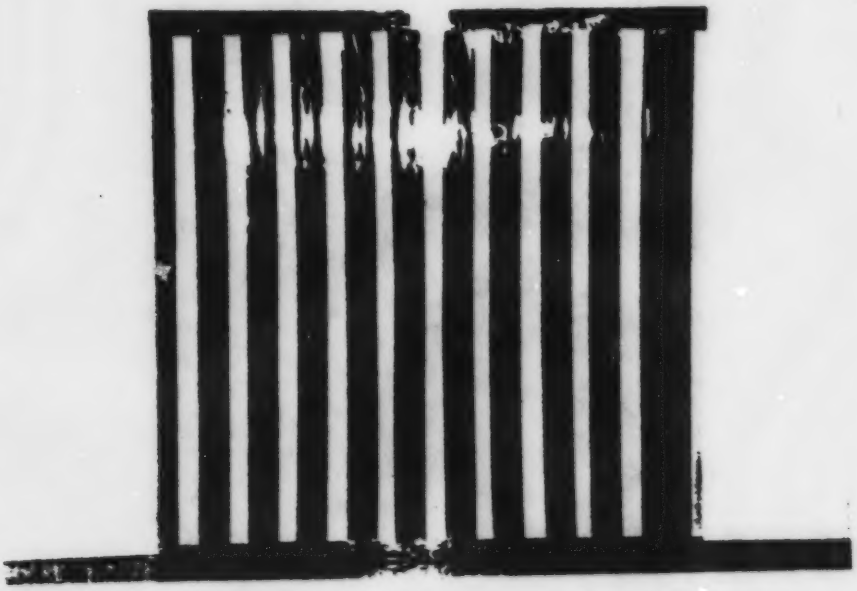
Photo No. 15

This air barrier is a plastic membrane perforated with many thousands of small holes (4.3 holes/cm^2). It is supposed to act as an air barrier by preventing air infiltration while allowing water vapour diffusion.

Under pressure, the creases were noticed in the paper fiber, but the paper was not torn or ripped. Similarly, the adhesive tape showed perfect adherence to the surface and no problem was observed in this regard.

SPECIMEN NO. 15: Adhesive tape on perforated polyethelene air barrier joint.
